## 4-POINT INSPECTION

# HOME INSPECTION REPORT

SEP 16, 2026

**9964 Stockbridge Dr, Tampa FL 33626**

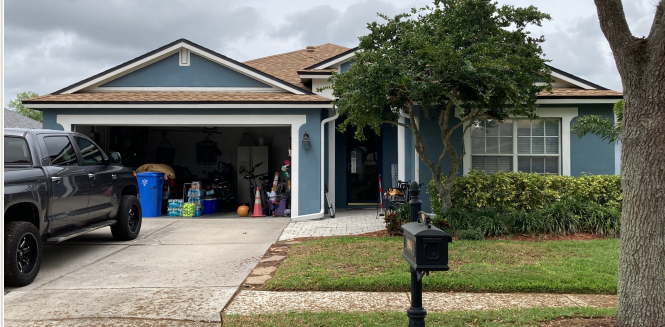
**Dwelling - each side**

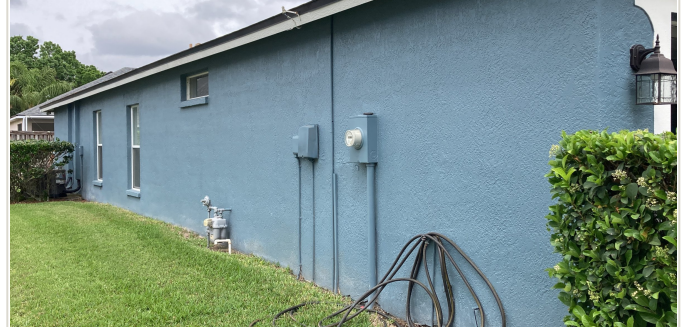
**Dwelling - each side**

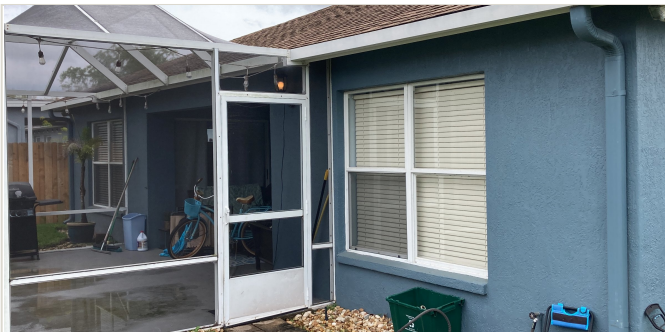
**Dwelling - each side**

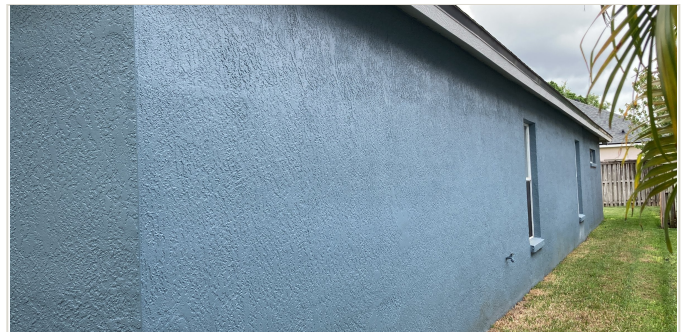
**Dwelling - each side**

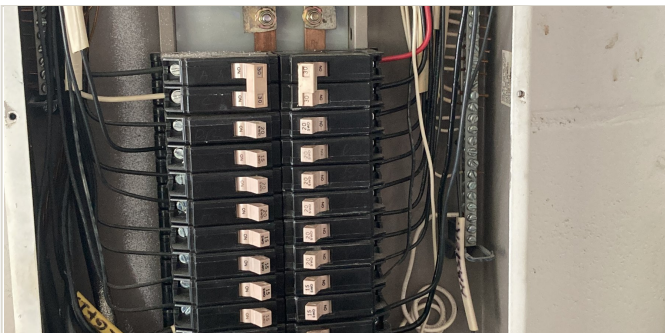
No electrical hazards observed - no cloth wiring, knob-and-tube, aluminum branch wiring, or unsafe conditions noted.

**Electrical box with panel off**
